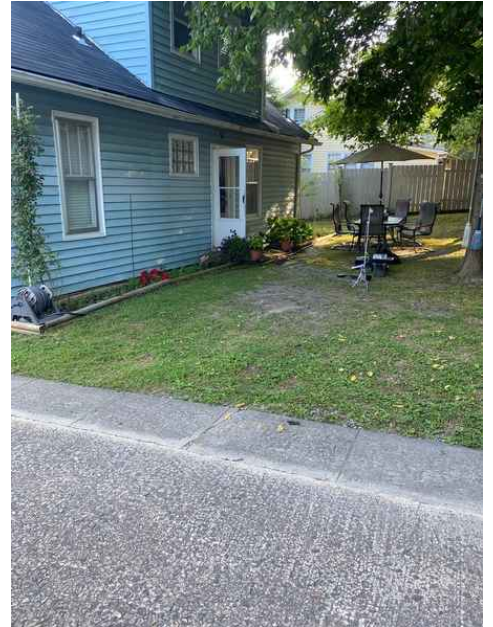
FRONT OF HOME

IMPROPER GRADING

The current configuration of the grading will not allow rainwater to run away from the home properly in the referenced area(s) or portions of the referenced area(s). Grading is either wrong or right, with no gray areas in between. The grading either slopes away from the structure (Right-Positive Grading), is flat (Wrong), or slopes towards the structure (Wrong-Negative Grade). Even though no repercussions may be present at the time of inspection due to improper grading, the possibility of moisture infiltration through foundation walls is always possible during heavy rainfall events.

Flat grading and negative grading allows the soil in these areas to become saturated, once saturated the porous, permeable masonry foundation walls can wick this water out of the soil via capillary action. This can allow the masonry itself to become saturated and either evaporate this moisture into areas below grade in the form of water vapor, creating high humidity, or allow for moisture or water infiltration into areas below grade.

The soil is recommended to slope away from the structure, with a 6 inch drop in elevation, in the first 10 feet away (5% grade). When the proper grade can not be achieved a swale or drain should be installed as needed to manage rainwater runoff. Evaluation and repairs are recommended to be conducted to the grading as needed to allow for the proper runoff of rainwater by a grading contractor, foundation contractor, or other qualified contractor.

Recommendation
Contact a qualified professional.

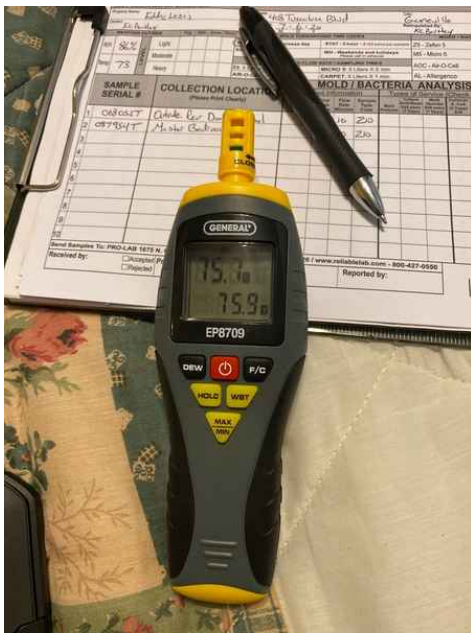
ELEVATED INDOOR HUMIDITY

Excessive humidity (>70%) was present in the structure at the time of testing.

A full evaluation of the structure is recommended to be conducted by a qualified contractor familiar with building sciences to determine the source of the high humidity with repairs made to lower the humidity levels.

Recommendation
Contact a qualified professional.

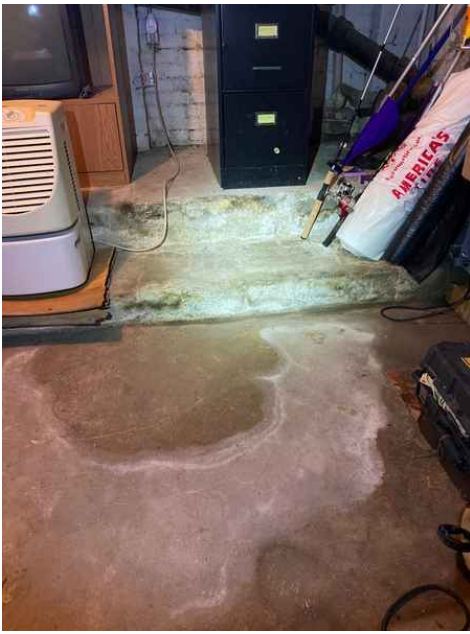
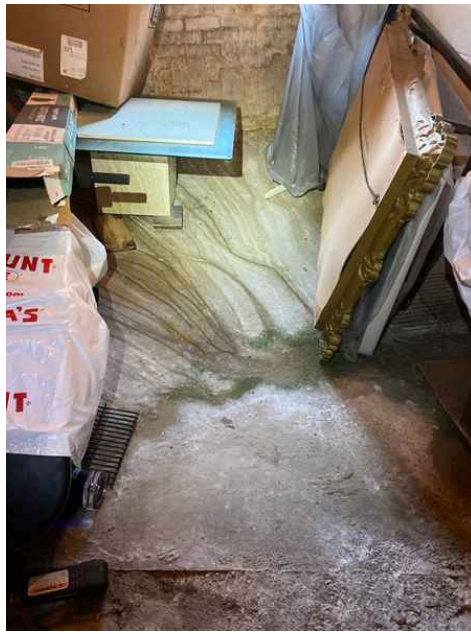
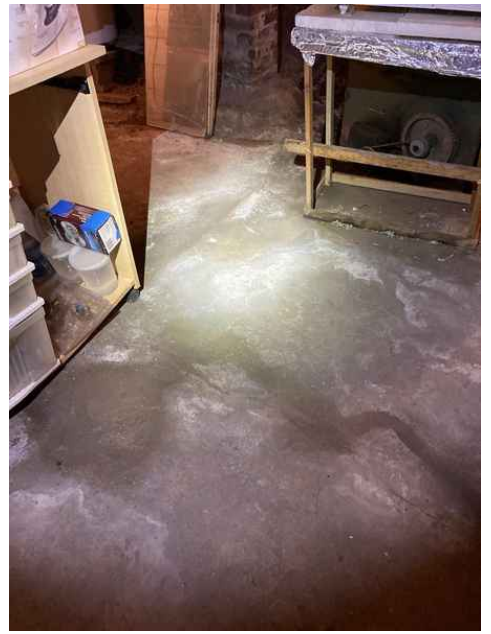
INDICATIONS OF MOISTURE INFILTRATION

There was evidence of past/present moisture infiltration into areas below grade. This moisture can come from grading deficiencies, downspout terminations or damage to drain tubes, a high water table, and/or other deficiencies.

A full evaluation is recommended to be conducted by a foundation or grading contractor to determine the exact source of the moisture or indications of past moisture, with repairs made to prevent or manage future moisture infiltration.

Contact a qualified professional.

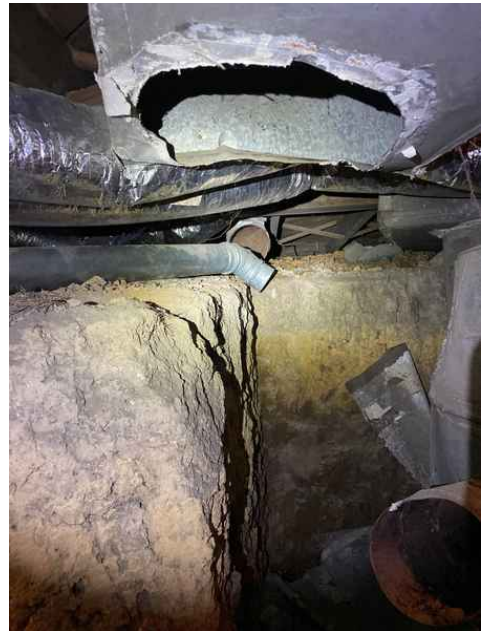
VAPOR BARRIER NOT PRESENT

A vapor barrier was not present covering the soil in the crawl space. A vapor barrier is recommended to cover the soil as several gallons of water may evaporate from the earth / dirt daily, adding moisture and condensation to the crawl space area. This can lead to the formation of fungal growth on framing components and other moisture related deficiencies. The installation of a minimum of a 6 mil poly vapor barrier is recommended to be conducted by a qualified person.

Contact a qualified professional.

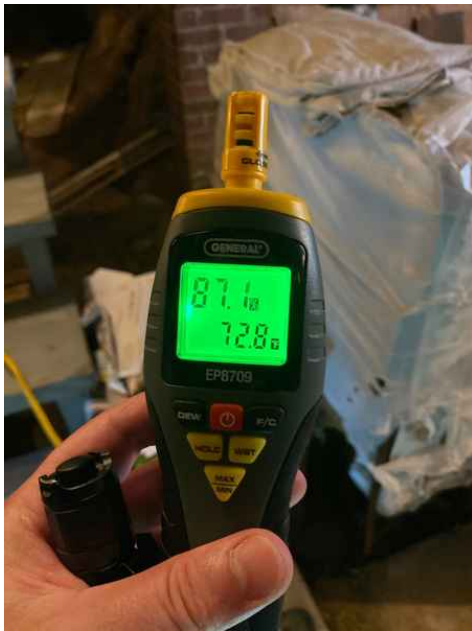
ELEVATED HUMIDITY

Excessive humidity (>70%) was present in the structure at the time of testing.

A full evaluation of the structure is recommended to be conducted by a qualified contractor familiar with building sciences to determine the source of the high humidity with repairs made to lower the humidity levels.

Contact a qualified professional.
