THE STRUCTURE GUARDIAN, LLC

MOLD INSPECTION/ASSESSMENT

1234 Main Street
Muskogee, OK 74403

03/21/2024 9:00AM

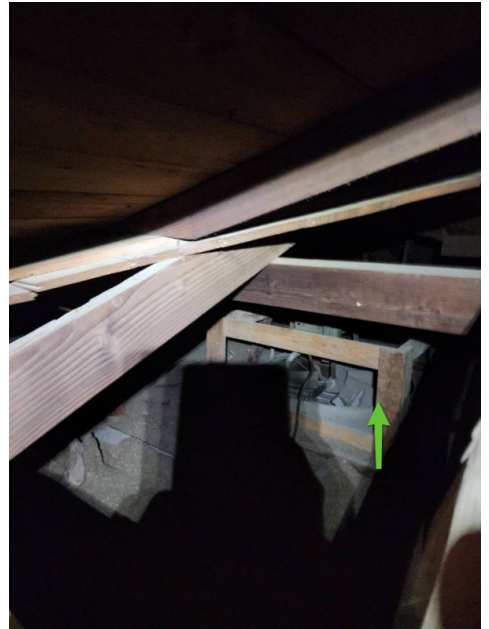
ATTIC ACCESS LIMITATIONS

Partial Flooring, No Access

Portions of the attic were not inspected due to limitations.

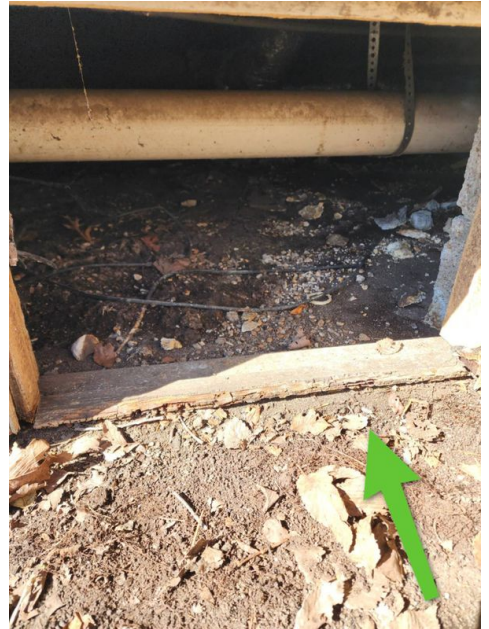
CRAWLSPACE ACCESS TOO SMALL

NORTHEAST

Crawlspace access too small for me to fit in. Crawlspace access are to be 18 inches by 24 inches.

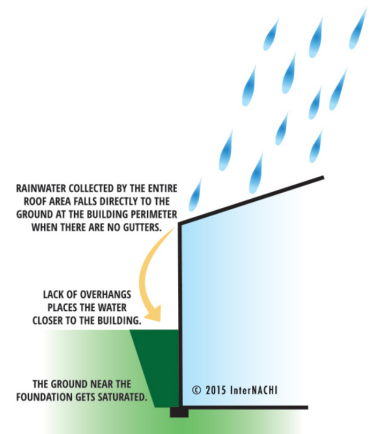
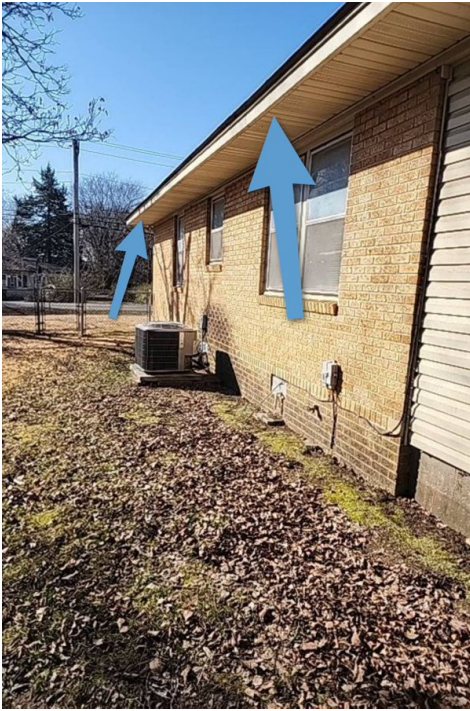
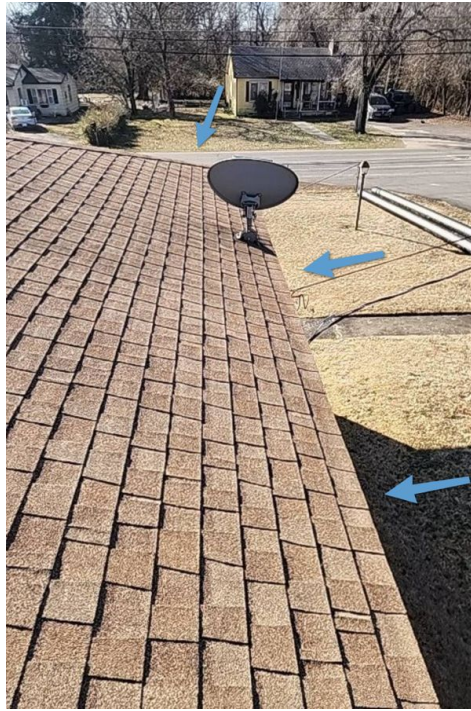
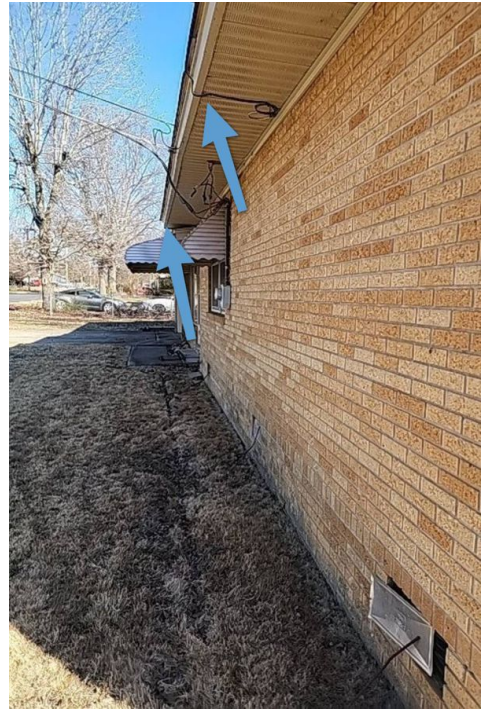
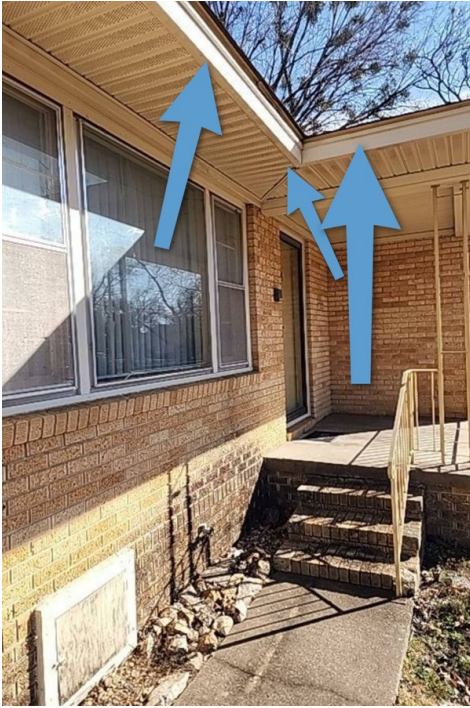
2.1.1 Roof / Gutters

NO GUTTERING PRESENT

EXTERIOR ROOFTOP PERIMETER

Gutters are necessary for most homes because they protect against water damage to the exterior and foundation of the home by directing rainwater away before it has time to settle in and cause damage such as from mold and mildew.

Contact a qualified professional.

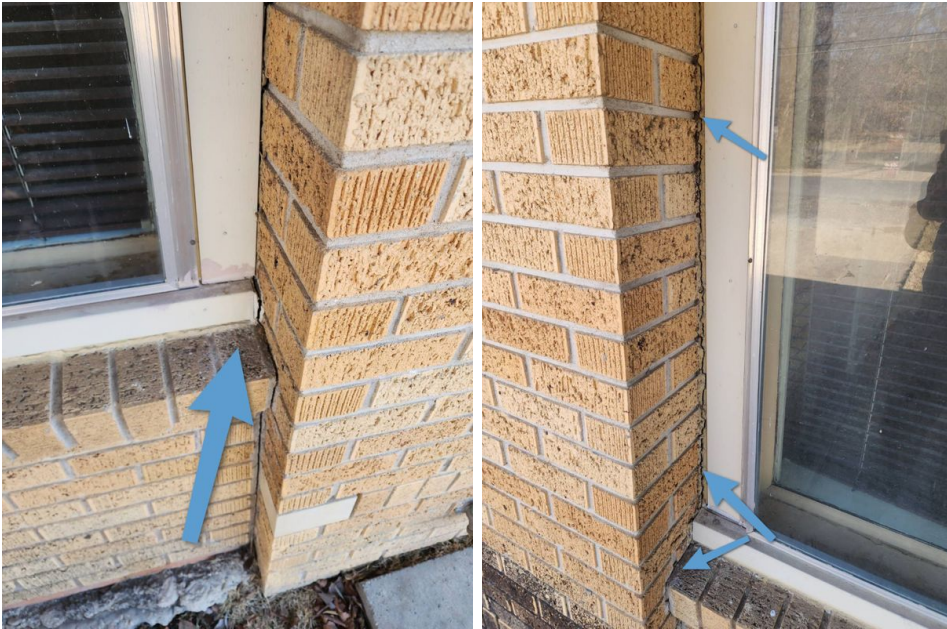
2.2.1 Site / Exterior

CAULK MAINTENANCE

NORTHWEST

Any penetrations or gaps in the exterior of the structure should be flashed or sealed properly to prevent moisture intrusion. Caulking is an ongoing maintenance task.

Contact a handyman or DIY project

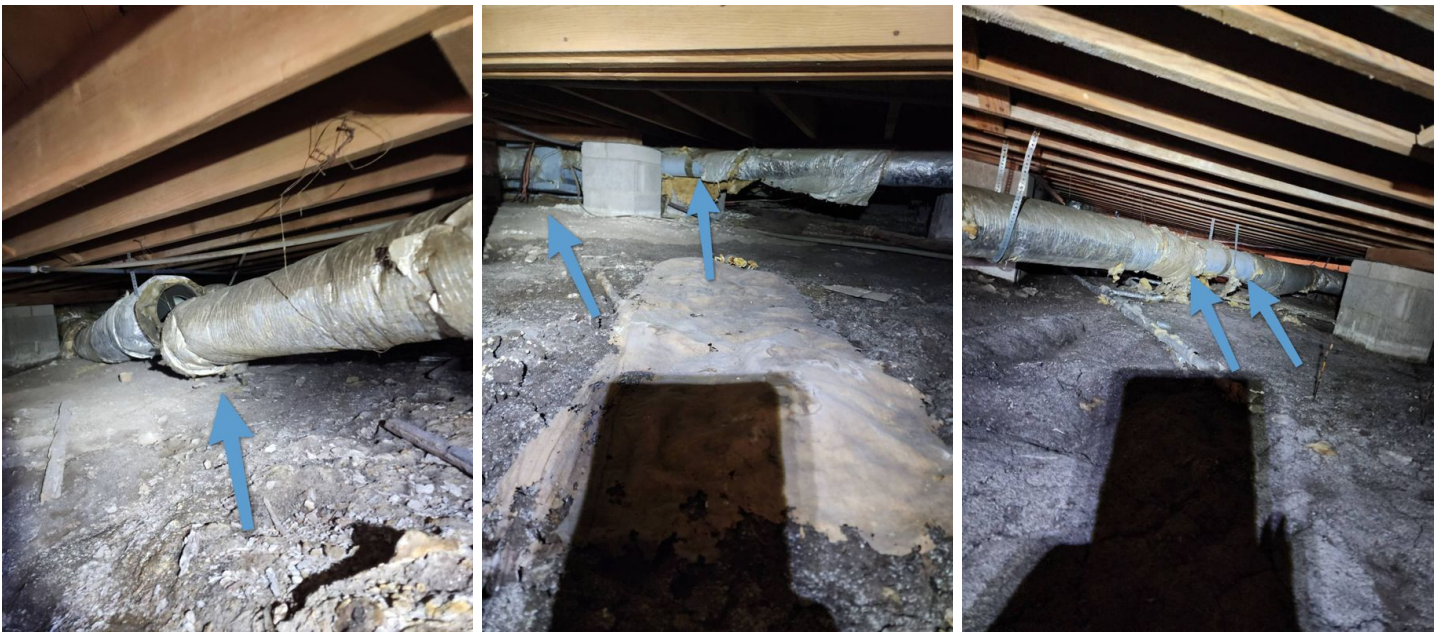
2.3.1 HVAC & Plumbing

DUCT INSULATION DAMAGED

CRAWLSPACE

Air duct insulation was damaged. Recommend a qualified HVAC contractor repair.

Contact a handyman or DIY project

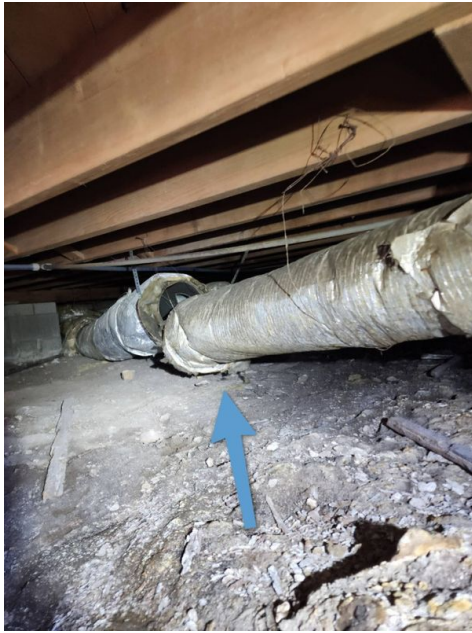
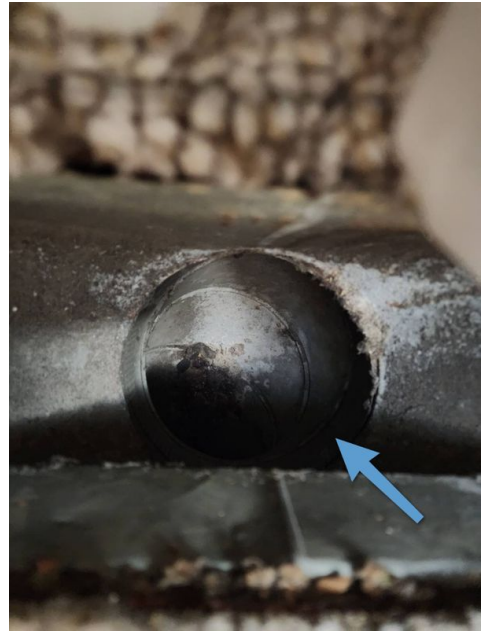
2.3.2 HVAC & Plumbing

DUCT CLEANING

The ducts or related components appeared dirty. It is recommended a qualified professional evaluate and clean the ductwork and related components.

Crawlspace

Living Room

Contact a qualified professional.

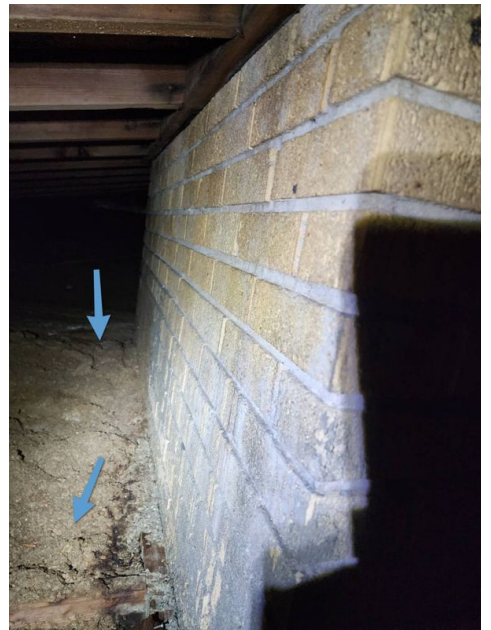
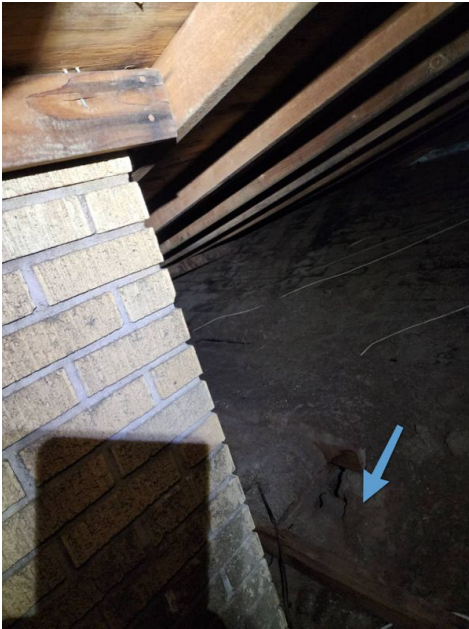
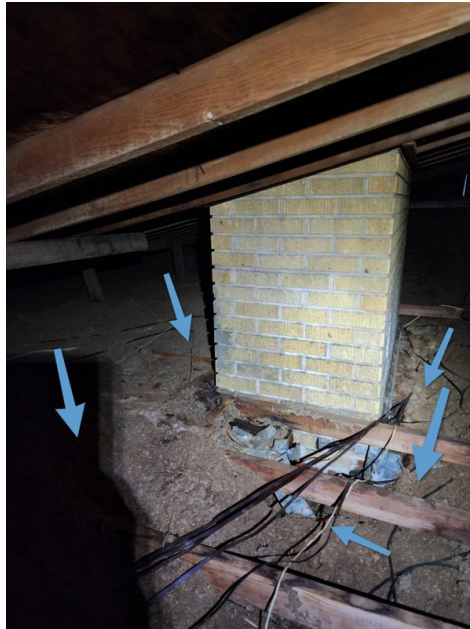
2.4.1 Attic / Interior

ATTIC ISULATION INSUFFICIENT

ATTIC

Attic insulation was insufficient in certain areas of the attic .Recommend an attic contractor evaluate and remedy.

Contact a qualified insulation contractor.

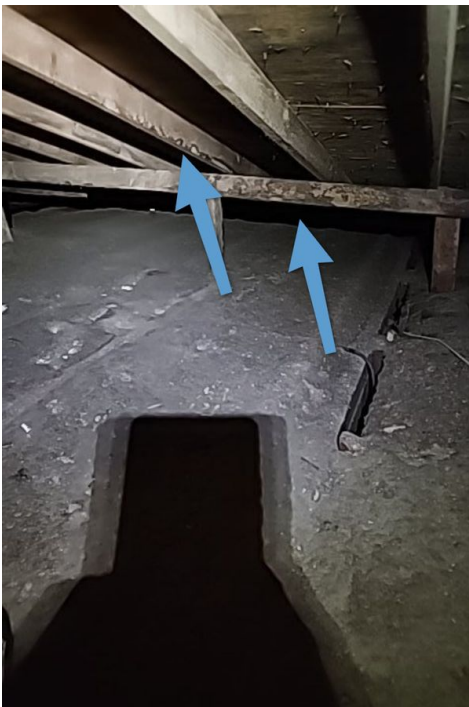
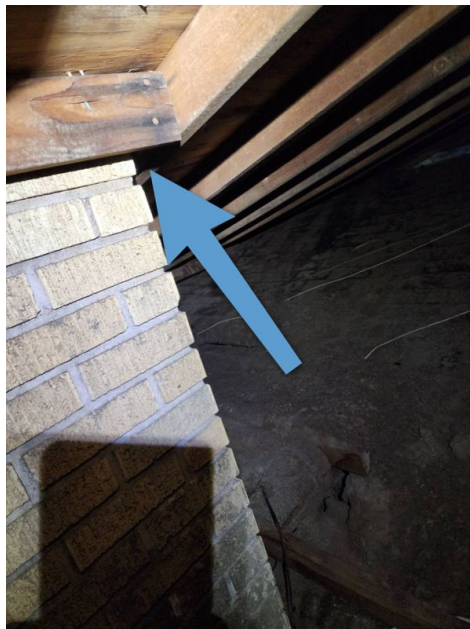
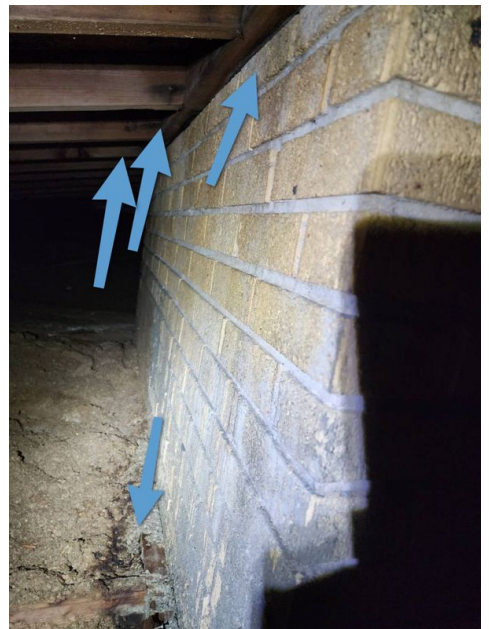
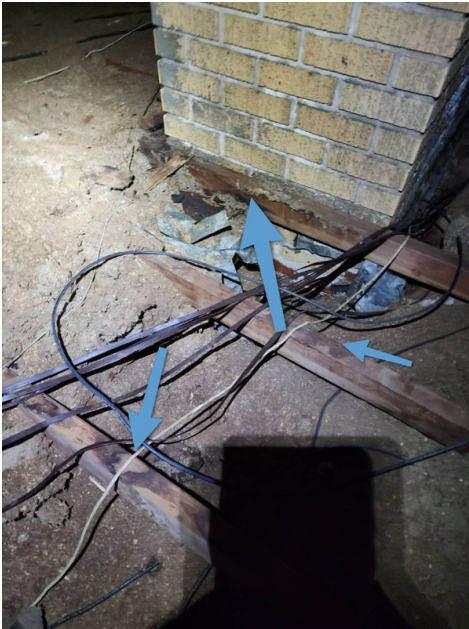
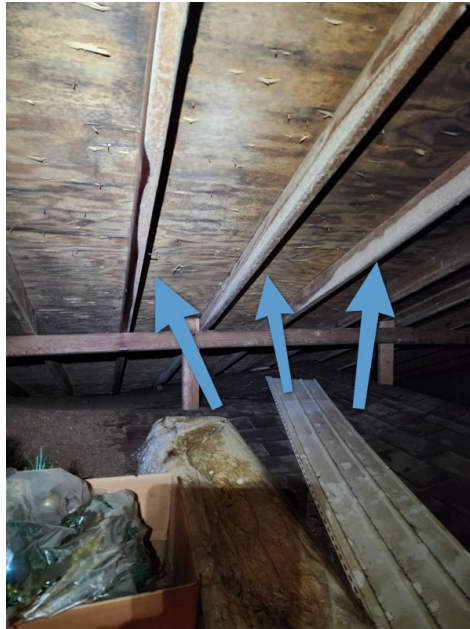
2.4.2 Attic / Interior

EXCESSIVE ATTIC STAINING

Excessive microbial like stains were noted. Recommend a qualified contractor evaluate the ventilation and insulation for improvement.

Recommended DIY Project

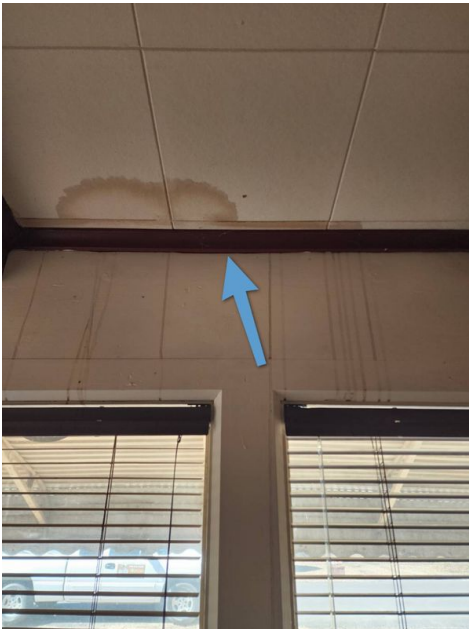
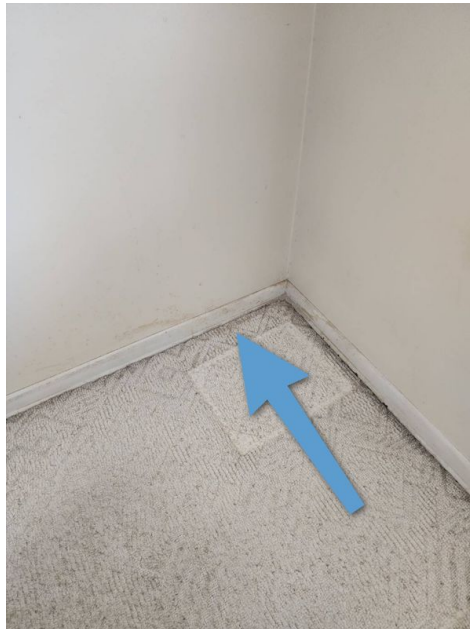
2.4.3 Attic / Interior

INTERIOR STAIN(S)

There is a stain on ceiling/wall that requires repair and paint. Source of staining should be determined and repaired prior.

Recommended DIY Project

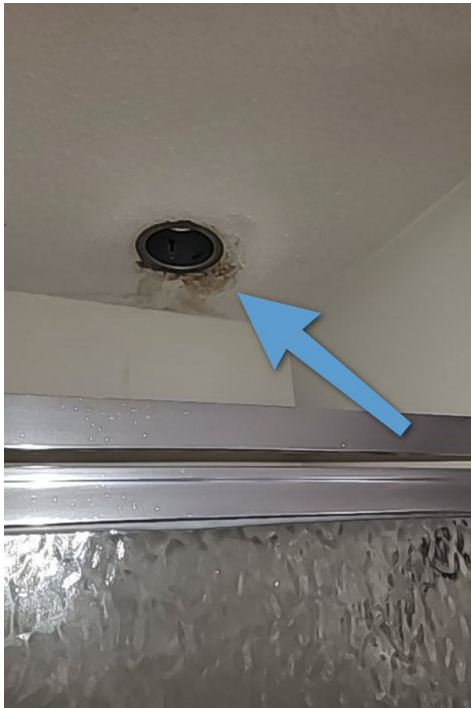
Bathroom

INTERIOR LEAK DAMAGE

EAST CLOSET, EAST HALLWAY CEILINGS WALL, EAST BATHROOM CEILINGS.

Stains on the ceiling appear to be the result of moisture intrusion. The source of leakage should be identified and corrected, and the ceiling repaired. Hidden defects or microbial activity may be present behind the material.

Recommended DIY Project

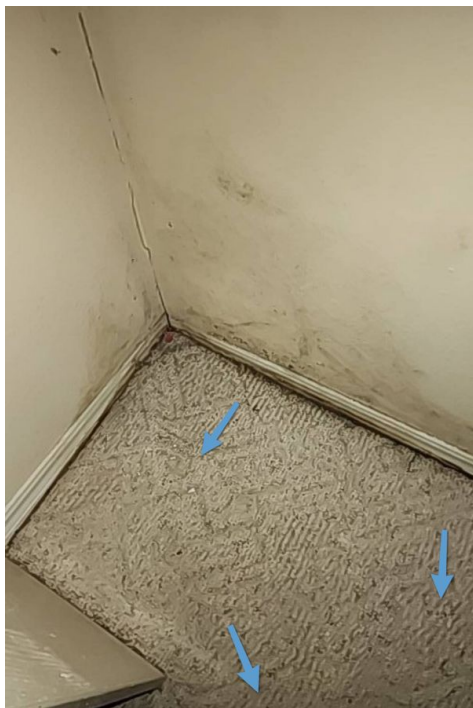
2.4.5 Attic / Interior

SPONGY FLOOR

ADD ON CLOSET

Floors had areas of sponginess or potential moisture damage. Improper installation may also be the cause. Recommend a qualified flooring contractor evaluate & repair areas of moisture.

Contact a qualified flooring contractor

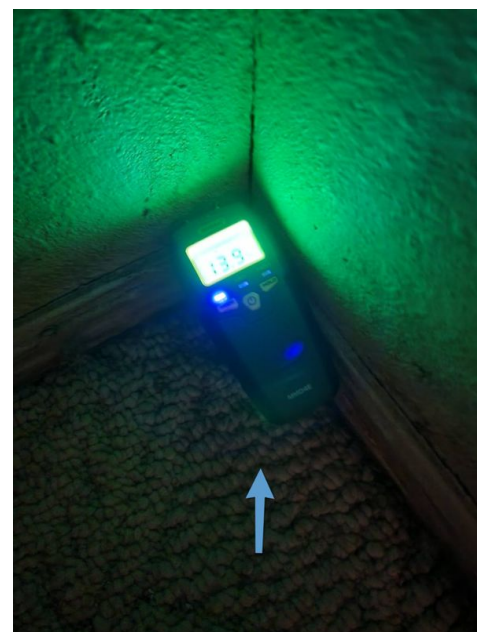
2.4.6 Attic / Interior

METER READINGS CLOSE TO ELEVATED.

ADD ON CLOSET

The moisture meter showed close to elevated levels of moisture in one or more areas. 16% is considered damp. Recommend repair and seal the source, to prevent future moisture intrusion/ cold air infiltration.

Recommended DIY Project

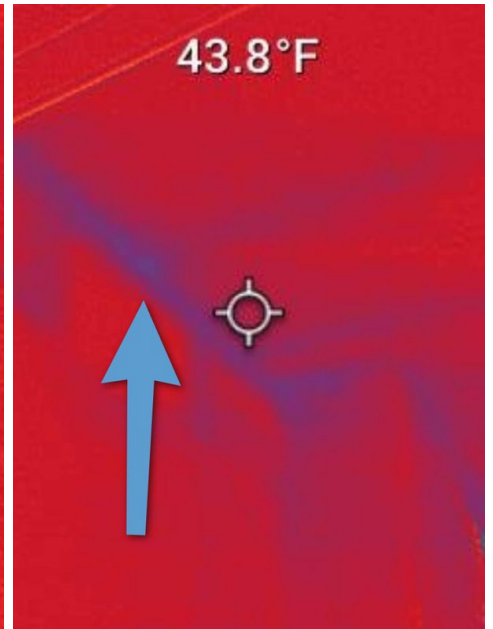
Add on hallway ceiling

COLD AIR INFILTRATION

ADD ON CLOSET, EAST HALLWAY CEILING.

Cold air infiltration detected during thermal scan of the interior walls/ceilings. Due to lack of insulation and or proper sealants.

Contact a qualified professional.

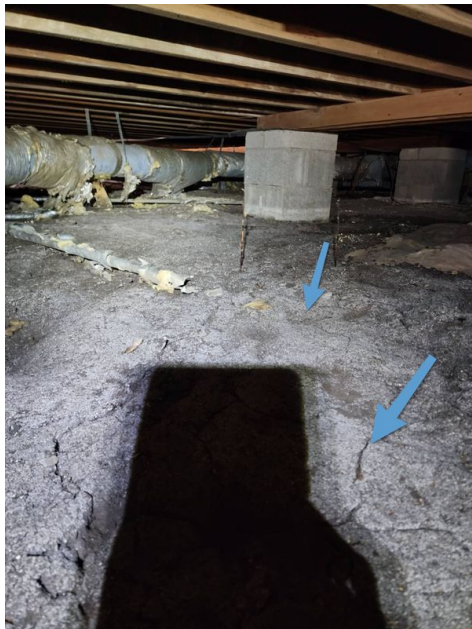
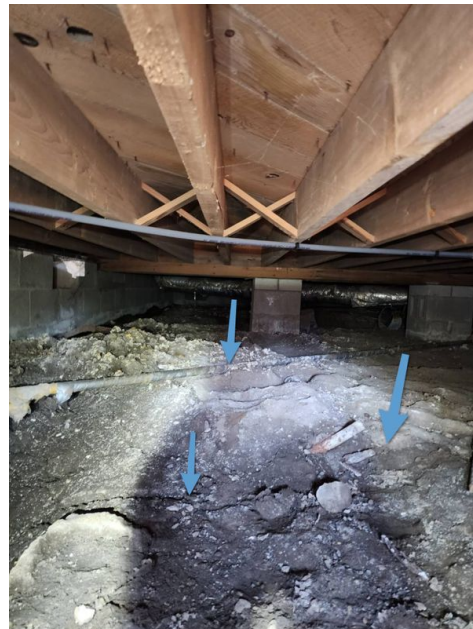
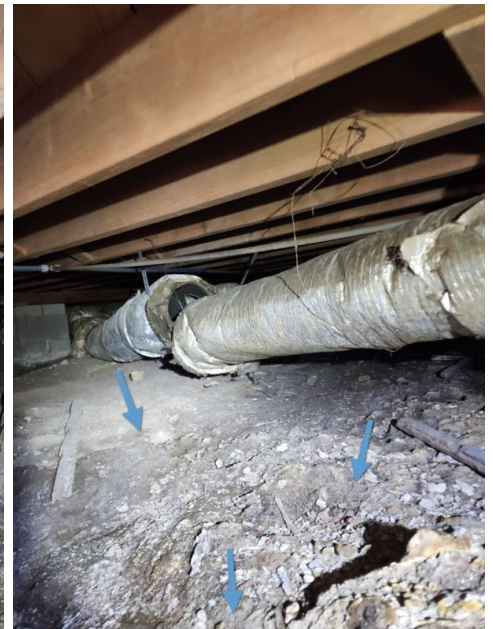
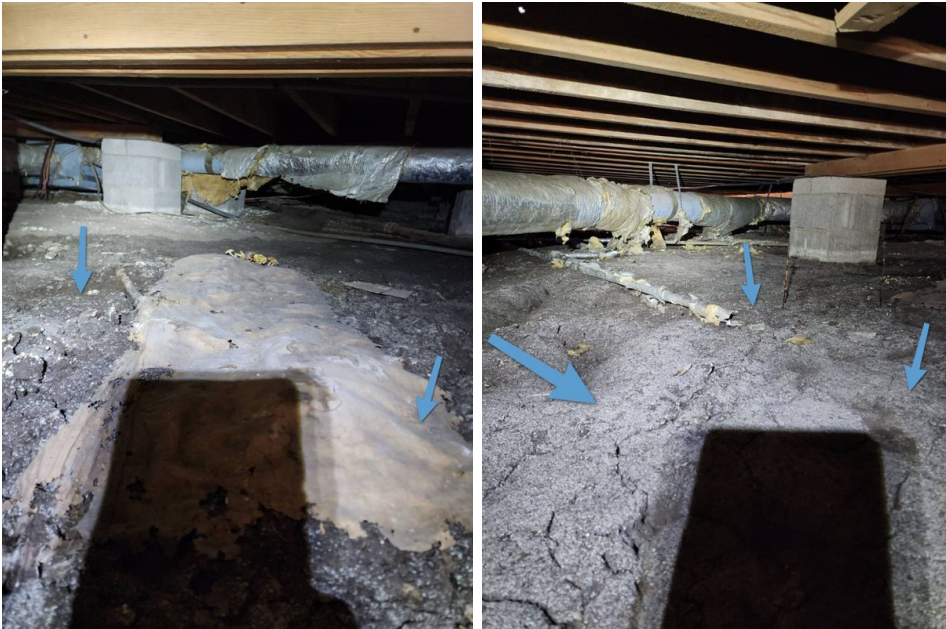
2.5.1 Basement / Crawlspace

VAPOR BARRIER

CRAWLSPACE

Proper vapor barrier installation can reduce moisture in the crawlspace area and make for a cleaner and more navigable environment. Recommend repairs and modifications.

Contact a qualified professional.

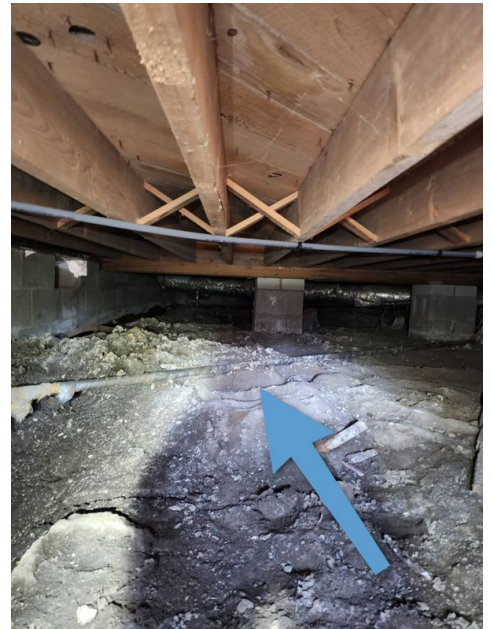
2.5.2 Basement / Crawlspace

MUSTY SMELL

CRAWLSPACE ,WEST

A musty smell was noted. This could be due to moisture intrusion or lack of ventilation. Recommend vapor barriers and ventilation.

Recommended DIY Project

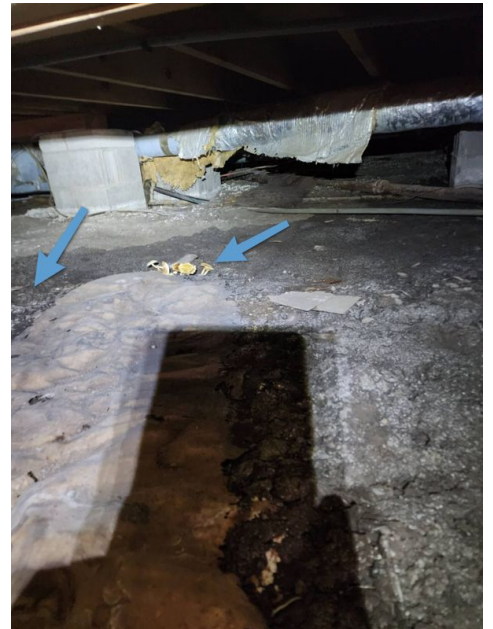
2.5.4 Basement / Crawlspace

MICROBIAL ACTIVITY

Observed signs of microbial like growth in one or more areas of the crawlspace. Proper ventilation and vapor barriers are recommended. Clean affected area's with white vinegar/soap mixture before installing vapor barriers.

Contact a qualified professional.

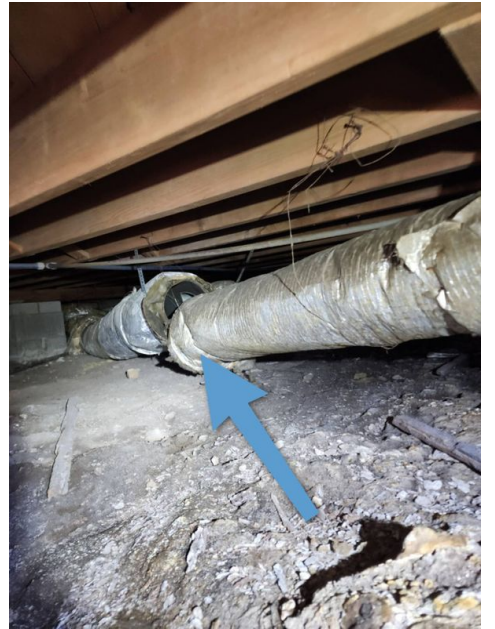
2.5.5 Basement / Crawlspace

DUCTWORK INSULATION

EAST , NORTH CRAWLSPACE.

Damaged ductwork insulation was found on the date of inspection.

Contact a qualified professional.

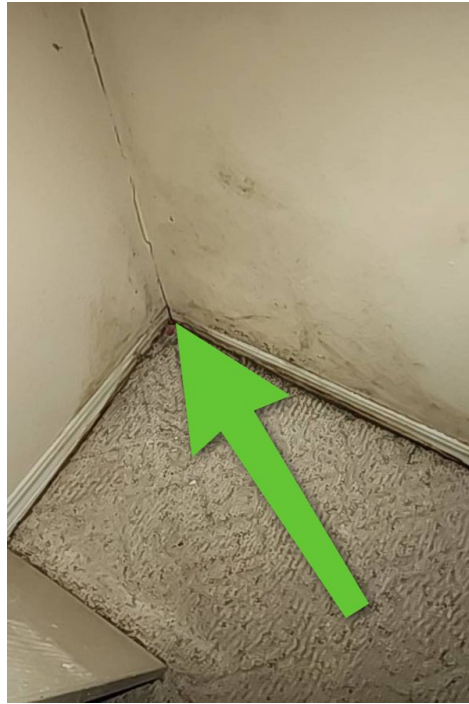
Swabbed closet wall intersection

Mold spore count taken via air sampling was not elevated at the time of inspection. Swab samples taken in other areas of the property were labeled as "unusual" meaning the presence of growth was observed in the analyzed sample. An abundance of spores are present, and or growth structures including Hyphae and/or fruiting bodies are present and associated with one or more types of mold/fungi analyzed in the samples.
