# THE STRUCTURE GUARDIAN, LLC 9189160599

# ROOM-BY-ROOM RESIDENTIAL

1234 Main Street Muskogee, OK 74403

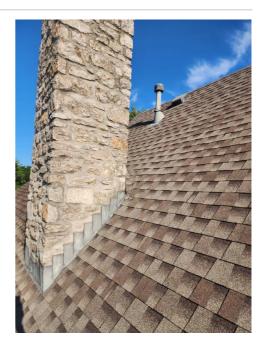
## **COULD ONLY PARTIALLY INSPECT**

Could only partially inspect due to pitch of the roof

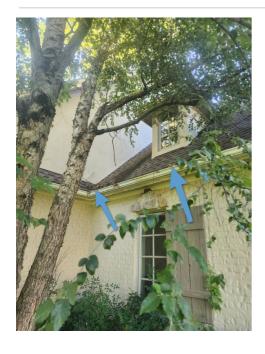
3.2.1 Roof Drainage Systems

## **DEBRIS**

Debris has accumulated in the gutters. Recommend cleaning to facilitate water flow.

Contact a qualified roofing professional.

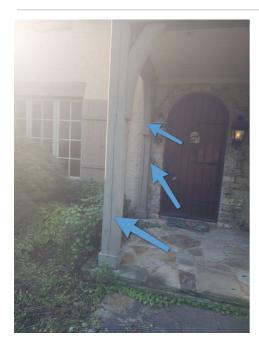
4.5.2 Decks, Balconies, Porches & Steps

### **POSTS CRACKING**

Post on front porch cracking monitor for future movement

Contact a qualified professional.

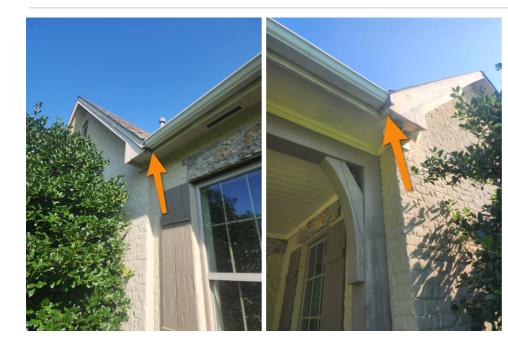
4.6.2 Eaves, Soffits & Fascia

### **FASCIA - ROTTED**

One or more sections of the fascia are rotted. Recommend qualified roofer evaluate & repair.

Contact a qualified roofing professional.

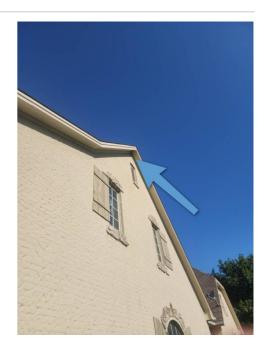
4.6.4 Eaves, Soffits & Fascia

#### **WASPS NEST**

Wasp nests were visible under the soffits. Recommend a qualified exterminator evaluate and remove.

Contact a qualified pest control specialist.

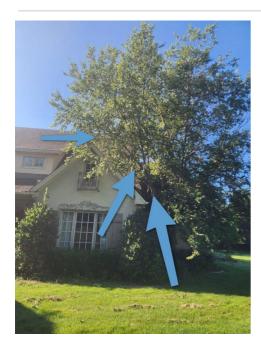
4.7.2 Vegetation, Grading, Drainage & Retaining Walls

## **TREE OVERHANG**

Trees observed overhanging the roof. This can cause damage to the roof and prevent proper drainage. Recommend a qualified tree service trim to allow for proper drainage.

Contact a qualified tree service company.

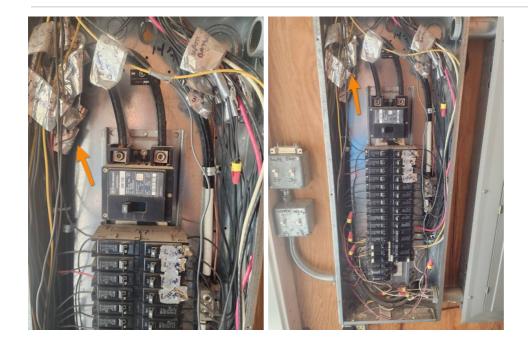
6.2.1 Main & Subpanels, Service & Grounding, Main Overcurrent Device

#### **METAL DUCT TAPE**

Metal duct tape is flammable therefore should not be in a breaker box.

Contact a qualified electrical contractor.

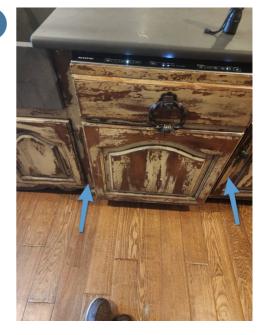
7.1.1 Dishwasher

#### **DISHWASHER NOT SECURE**

Contact a qualified professional.

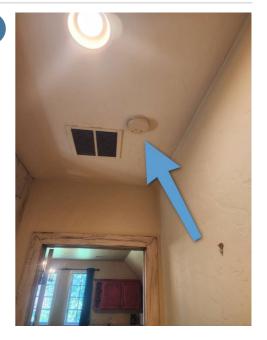
8.9.1 Smoke Detectors

### **OLD SMOKE DETECTORS**

Replace with new carbon monoxide and smoke detectors.

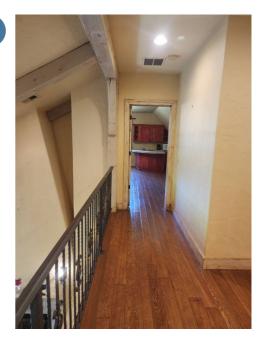
8.10.1 Carbon Monoxide Detectors

### **NONE PRESENT**

Install carbon monixide detectors.

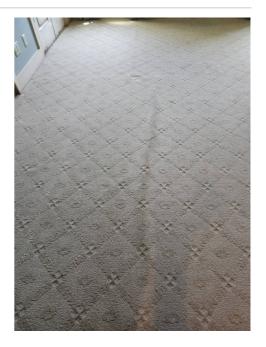
9.4.1 Floors

Floors in the home exhibited moderate surface wear along major paths of travel. Recommend a qualified flooring contractor evaluate for possible re-finish.

Contact a qualified flooring contractor

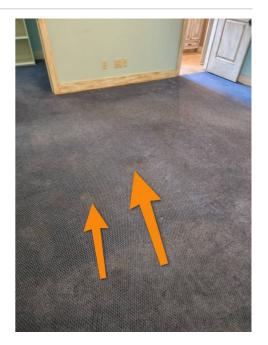
10.4.1 Floors

Carpet had areas of staining or discoloration. Recommend a thorough steam clean by a qualified carpet cleaning company

Contact a qualified cleaning service.

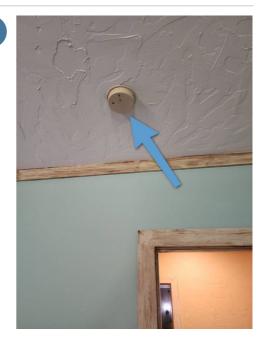
17.3.1 Smoke Detectors

**OLD SMOKE DETECTORS**

Old Smoke Detectors need to be replaced.

Contact a qualified professional.
