THE STRUCTURE GUARDIAN, LLC

MOLD INSPECTION/ASSESSMENT

1234 Main Street
Muskogee, OK 74403

03/21/2024 9:00AM

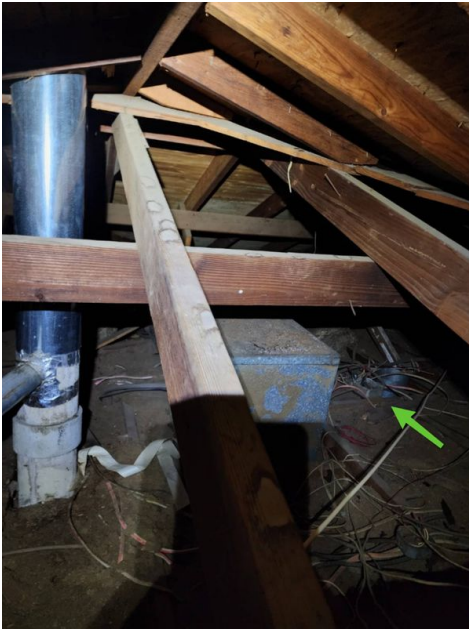
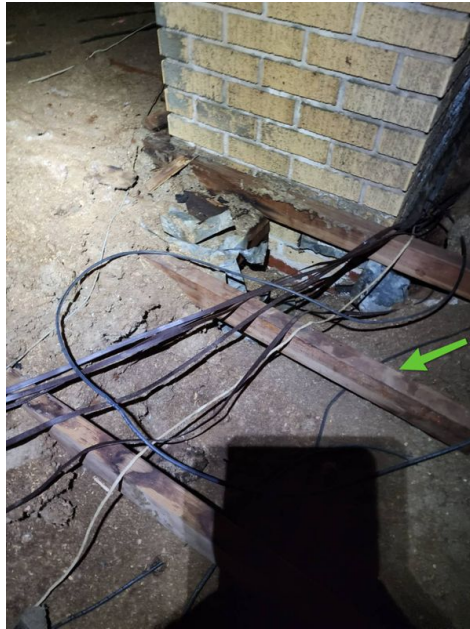
Partial Flooring, No Access

Portions of the attic were not inspected due to limitations.

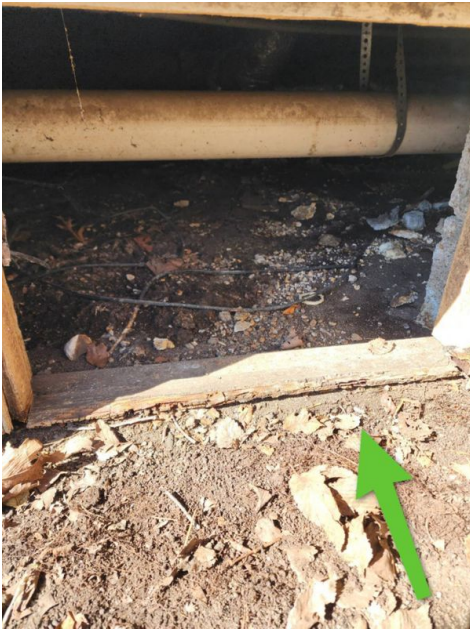
NORTHEAST

Crawlspace access too small for me to fit in. Crawlspace access are to be 18 inches by 24 inches.

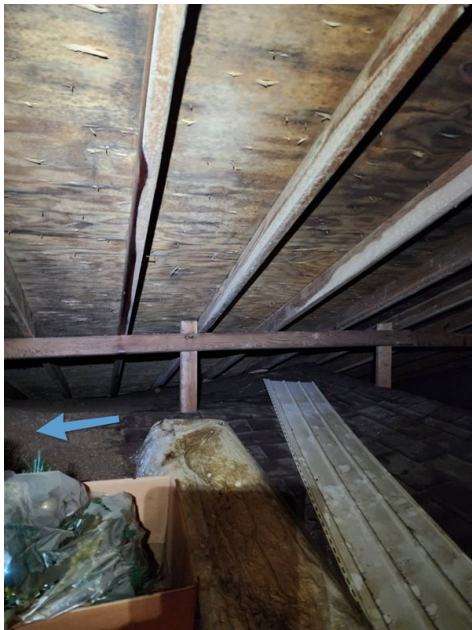
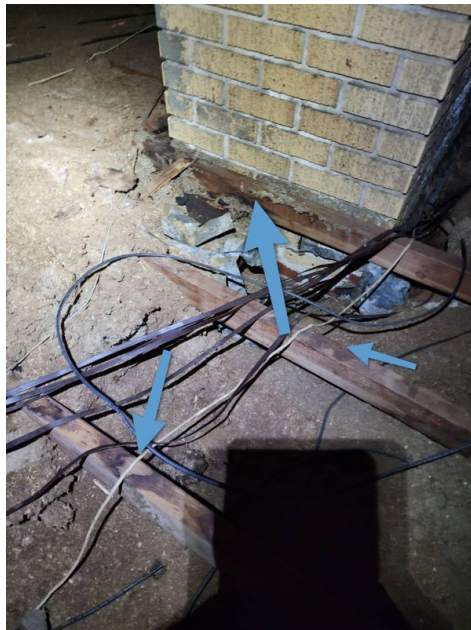
Deferred Maintenance

Attic insulation was insufficient in certain areas of the attic .Recommend an attic contractor evaluate and remedy.

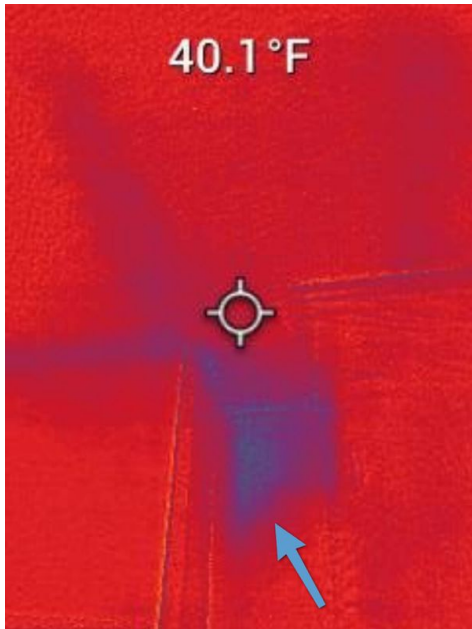
Hallway ceiling

Stains on the ceiling appear to be the result of moisture intrusion. The source of leakage should be identified and corrected, and the ceiling repaired. Hidden defects or microbial activity may be present behind the material.

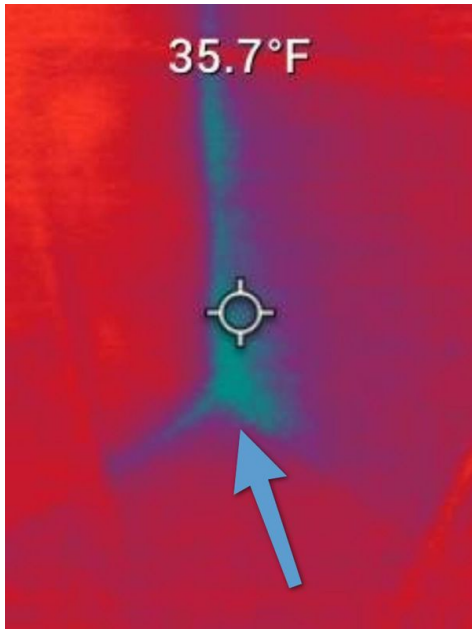
Add on closet

Cold air infiltration detected during thermal scan of the interior walls/ceilings. Due to lack of insulation and or proper sealants.

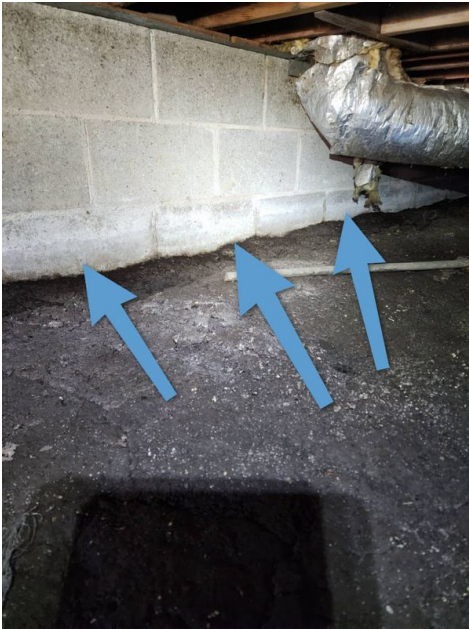
Observed signs of microbial like growth in one or more areas of the crawlspace. Proper ventilation and vapor barriers are recommended. Clean affected area's with white vinegar/soap mixture before installing vapor barriers.

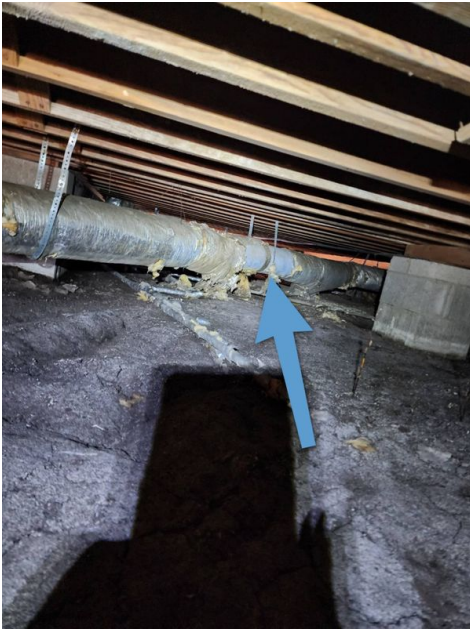
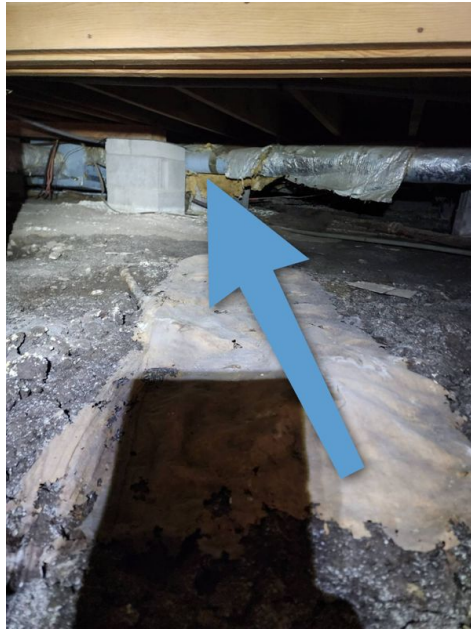
Damaged ductwork insulation was found on the date of inspection.

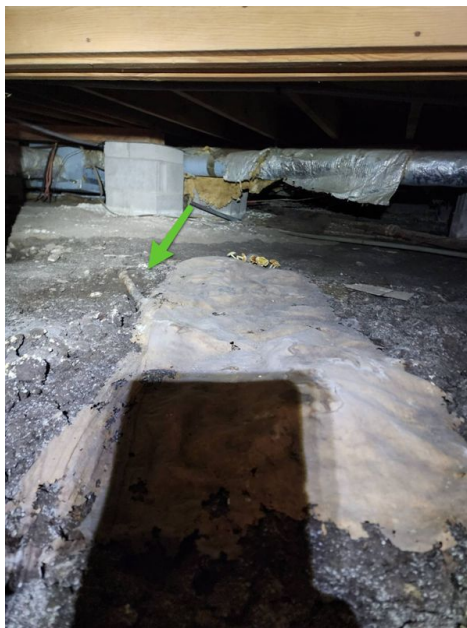
Swabbed white growth
